ZINGA	Vapour Blast + TSA	QA/QC Department Pull Off Test Report

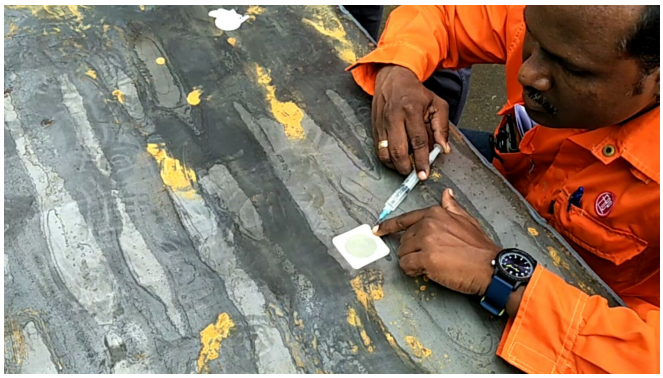
Photo 1 	Comment: Test panel prior to Blasting and TSA Date : 21April 2018
Photo 2

Comment: Above : Preparation for Salt Test Below : Salt Test on Plate prior to blasting

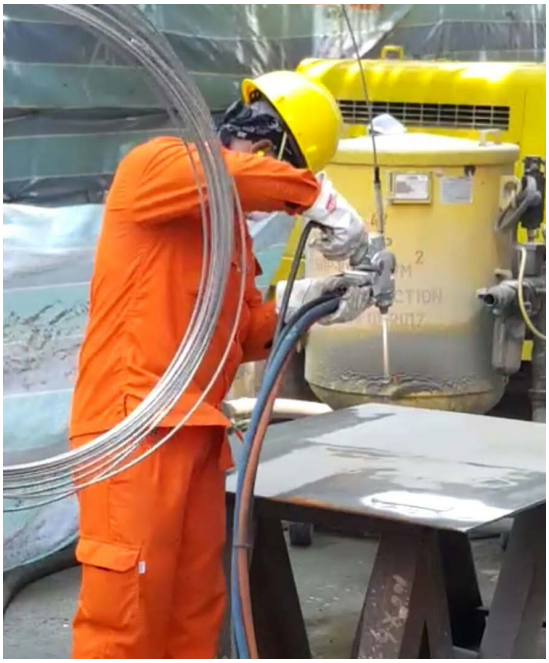
Photo 5

Photo 3 	Comment: Blasting to SA 2.5 using 1. SATBlast Vapor Blasting machine 2. Abrablast Recycled Glass abrasives with Water 3. 390 Compressor @ 7.5 bar
Photo 4 	Comment: Test Panel Blasted to SA 2.5 Salt Test shows some reduction in Salt content Profile Test 1. 92 microns 2. 102 microns 3. 98 microns

Comment: Application of TSA to average 300 microns dft
Photo 6 	Comment: Dolly 1 Planted : 22 APR 18 Time : 1310 Hrs Pull Off Test: 24 APR18 Time : 1130 Hrs Result: 10.55 MPA 100% Adhesion Failure Dolly 2 Planted : 22 APR 18 Time : 1310 Hrs Pull Off Test: 24 APR18 Time : 1135 Hrs Result: 8.75 MPA 100% Adhesion Failure

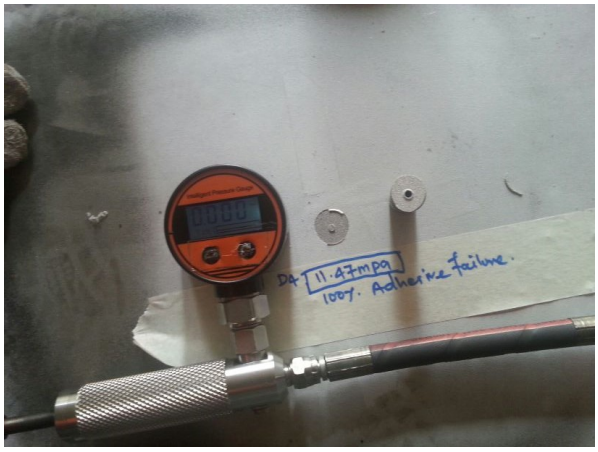
Photo 7

Comment: Dolly Planted 3 : 22 APR 18 Time : 1310 Hrs Pull Off Test: 24 APR18 Time : 1140 Hrs Result: 9.51 MPA 100% Adhesion Failure Dolly 4 Planted: 22 APR 18 Time : 1310 Hrs Pull Off Test: 24 APR18 Time : 1145 Hrs Result: 11.47 MPA 100% Adhesion Failure
	Comment: Dolly 5 Planted : 22 APR 18 Time : 1310 Hrs Pull Off Test: 24 APR18 Time : 1150 Hrs Result: 9.51 MPA 100% Adhesion Failure
